An Archaeological Assessment of Late-Medieval Trowbridge, Wiltshire

An Archaeological Assessment of Late-Medieval Trowbridge Town Centre, Wiltshire

Historic Building Consultations Report: HBC/W/19/13

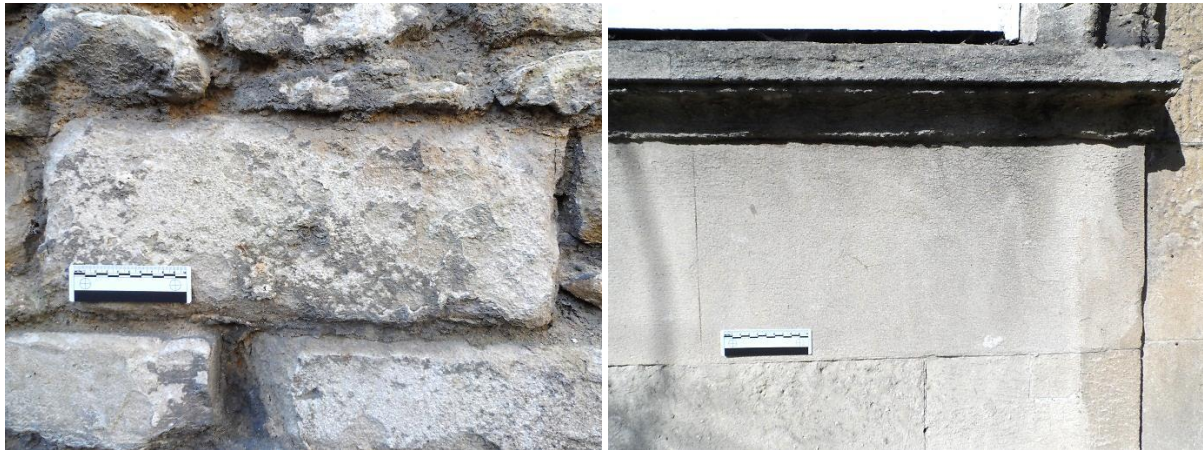
Figure 3 An example of re-used Oolitic Limestone (most likely from Dorset) in the walls around Trowbridge - above left - and the yellower local sand stone used in later Georgian fronts - above right

compared to the Georgian (1714–1837) and later buildings that use local Bath stone (Figure 3). Do these limestone blocks come from the demolished Saxo-Norman church? I would suggest almost certainly. Their size and style are consistent with the blocks unearthed by the archaeological excavations of Wessex Archaeology (*op. cit.*) and are in stark contrast to the yellow softer local sand stone used in later construction of the town's grand Georgian buildings.

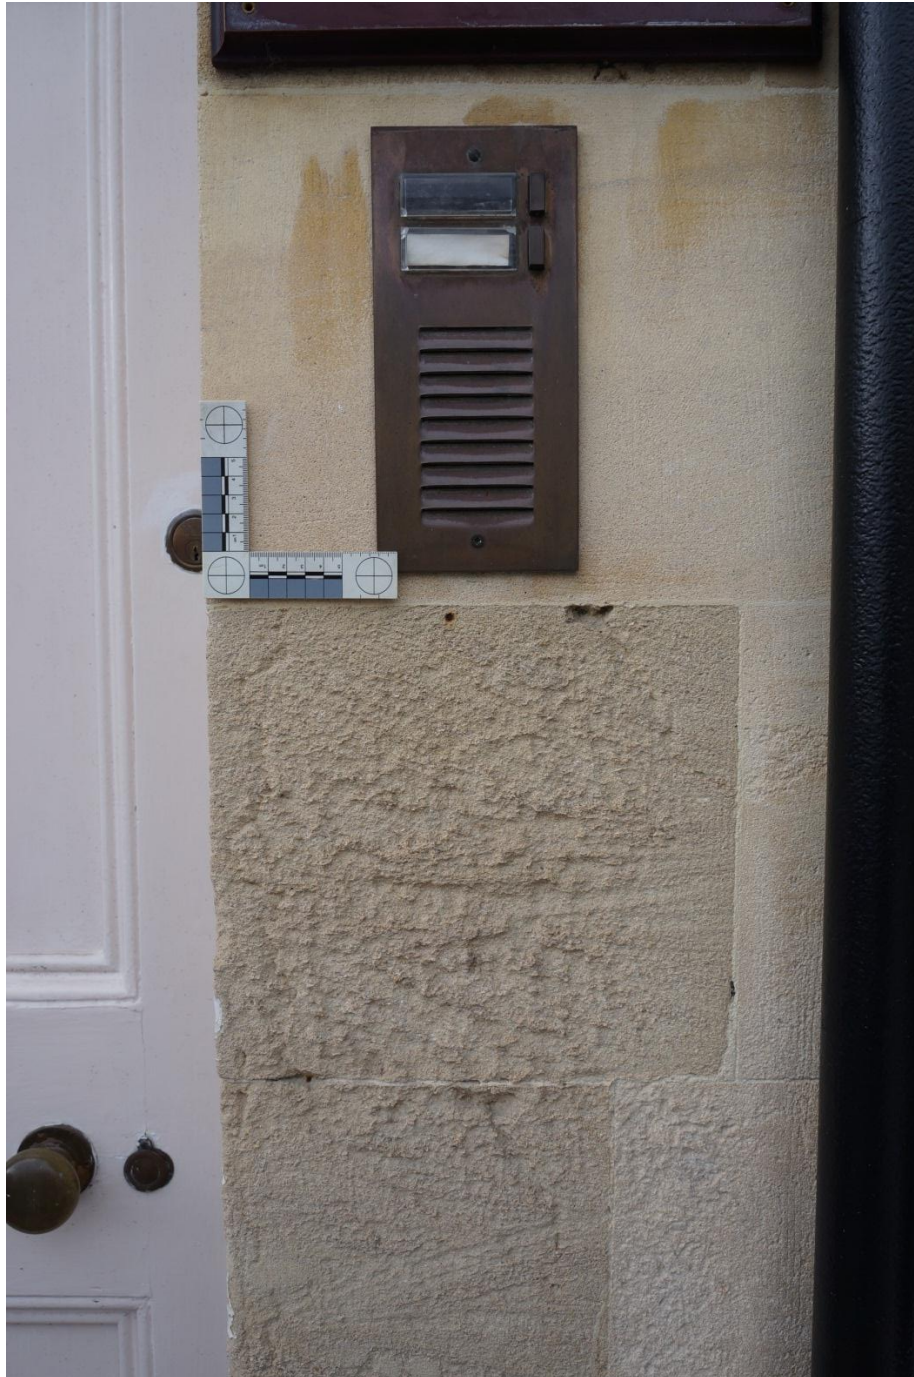
Figure 6 Georgian stone cladding c1789, used to re-front the medieval core of 63 Fore Street

One can also find “re-used” stone within various buildings around Trowbridge, again in conjunction with the darker local stone (Figure 5). Often the solid Limestone is used to form quoins (large corner stones used to strengthen a structure) as we can see in the images below. The medieval frontage of 63 Fore Street was also clad by the Georgians around 1789 using the softer local stone (Figure 19) which contrasts against the medieval stone used in the interior of the building (Figure 6).

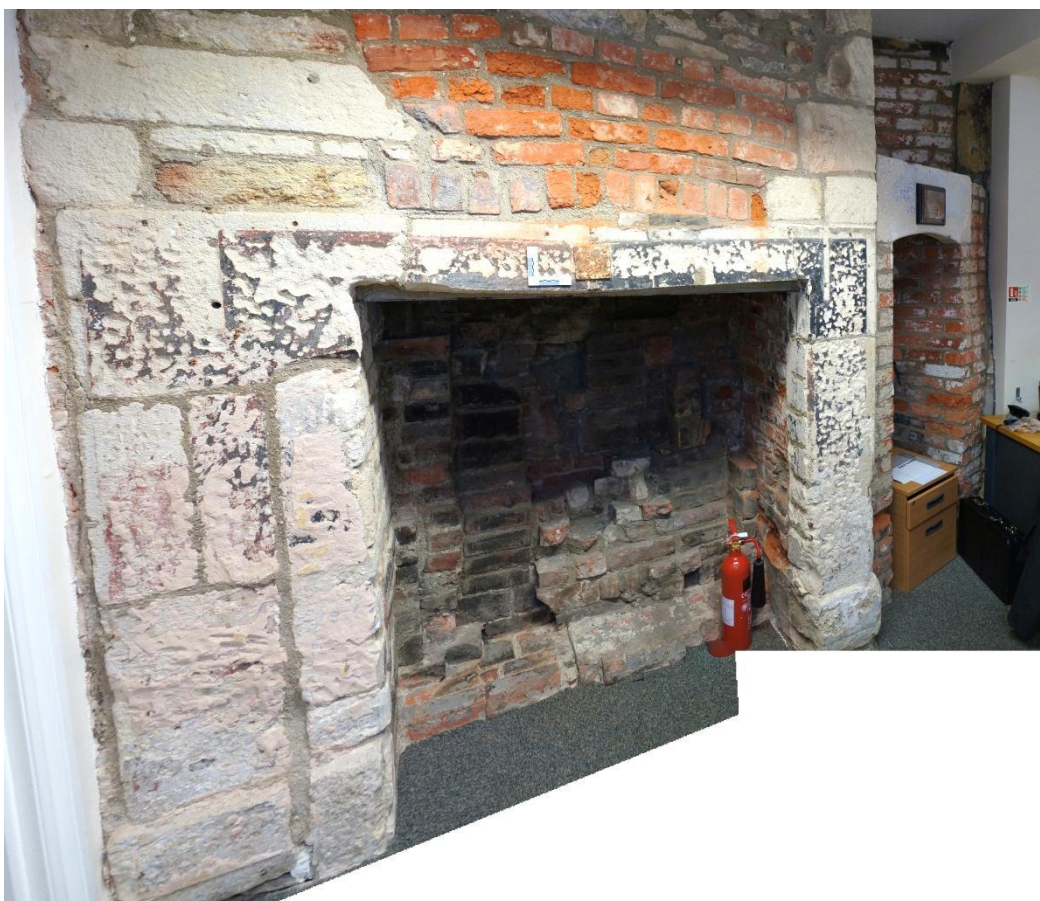
Figure 7 two stone fireplaces within the main shop area of 63 Fore Street, Trowbridge

This discussion aside, the significance of the fireplace cannot be ignored. Indeed, it is to Trowbridge's various medieval fireplaces that the report now focusses on. 63 Fore Street has three grand limestone and brick fireplaces. Two are adjacent in the larger front room facing the main street (Figure 7); the other is in an office to the left of the main room (Figure 8). If we suppose the three fireplaces are coeval (having the same date) with each other, we may ask where they originally came from - as stylistically they do not match with the building. The timber framed of the building has been dendrochronologically (tree-ring) dated to AD1513 (see Section 4.3) by Dr Andy Moir (Moir, 2013b, 1). The fireplaces however, would appear to stylistically pre-date 1513 by at least two centuries. Therefore, it can be assumed that the fireplaces are re-used. As we have already seen above, the archaeological investigations of the Saxo-Norman complex in Trowbridge centre yielded evidence of Anarchy Period (1139-1200) fireplaces (Graham and Davies, 1993, 70). I would therefore suggest it is possible the high status fireplaces of 63 Fore Street were originally from the Saxo-Norman complex. If the main fireplace in 63 Fore Street is examined closely, it is possible to see the remains of deer painted in brown upon a black background (Figure 9). The Normans are well known for their love of hunting deer and the present state of the paintings may suggest they are indeed original Norman depictions. Also, the fireplaces look "out of place" and their surroundings made to accommodate the pre-cut and shaped stone rather than the fireplace being made to fit into an existing hole. This also hints at the stone being re-used. Another example of a stone fireplace, this time with oak mantel, can be found in the cellar/undercroft of number 7 Fore Street, Trowbridge (Figure 10). It is unclear the original use of this fine undercroft (a brick lined and vaulted storage room under a building), suffice it to say that it must have been of high status based on the materials used. This includes a fine cut stone lintel above the entrance to the undercroft (Figure 11) and a fine cobbled floor.

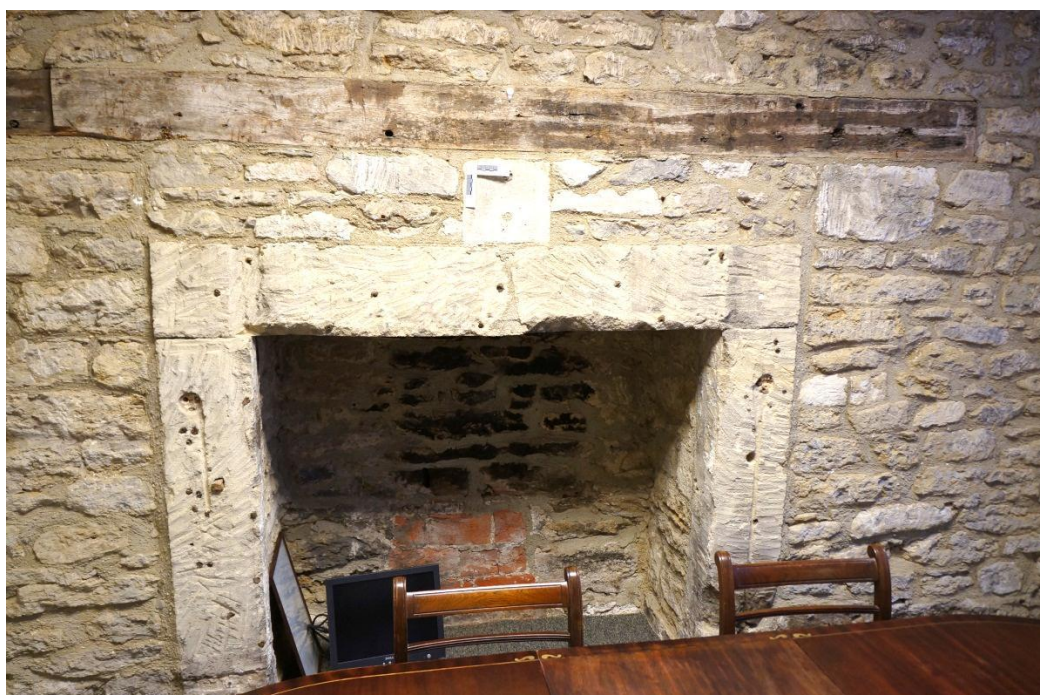
Figure 8 a stone fireplace in a ground floor office off the main shop area in 63 Fore Street, Trowbridge

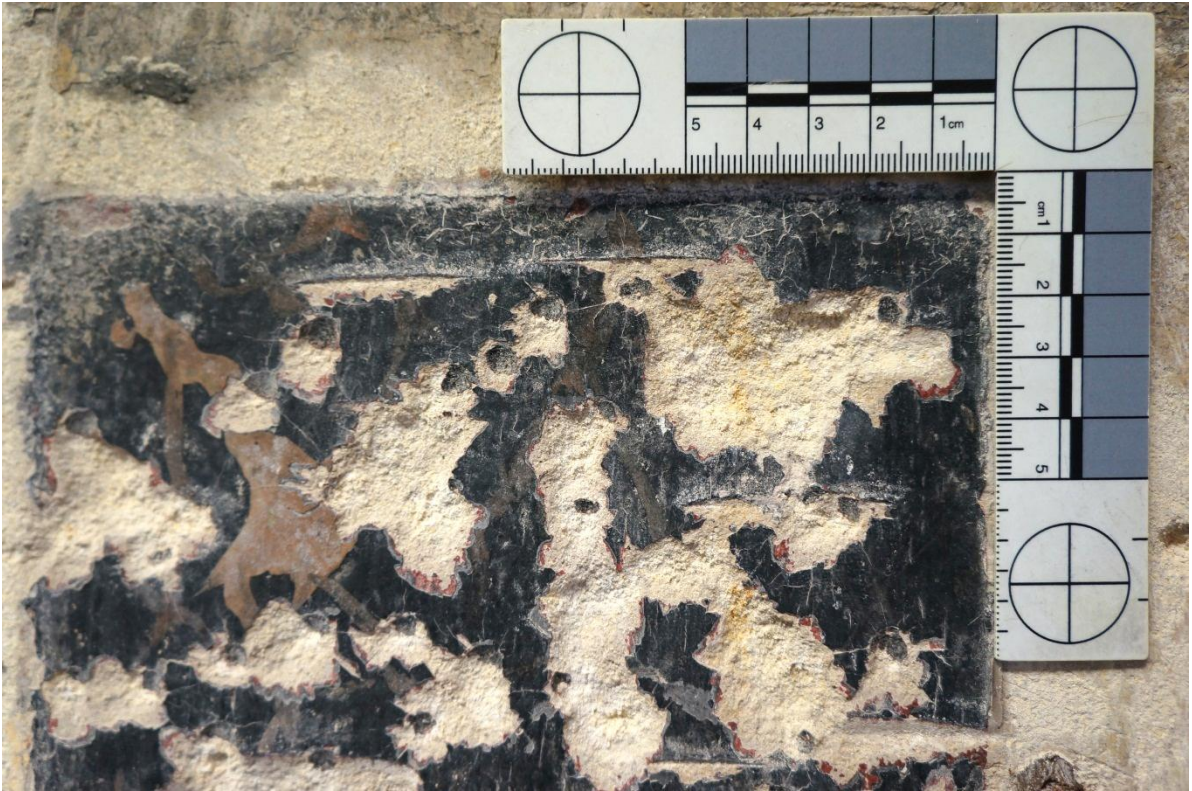
Figure 9 a photograph taken of the top right mantel of the main fireplace of 63 Fore Street. To the right of the image one can still make out a painting of a deer

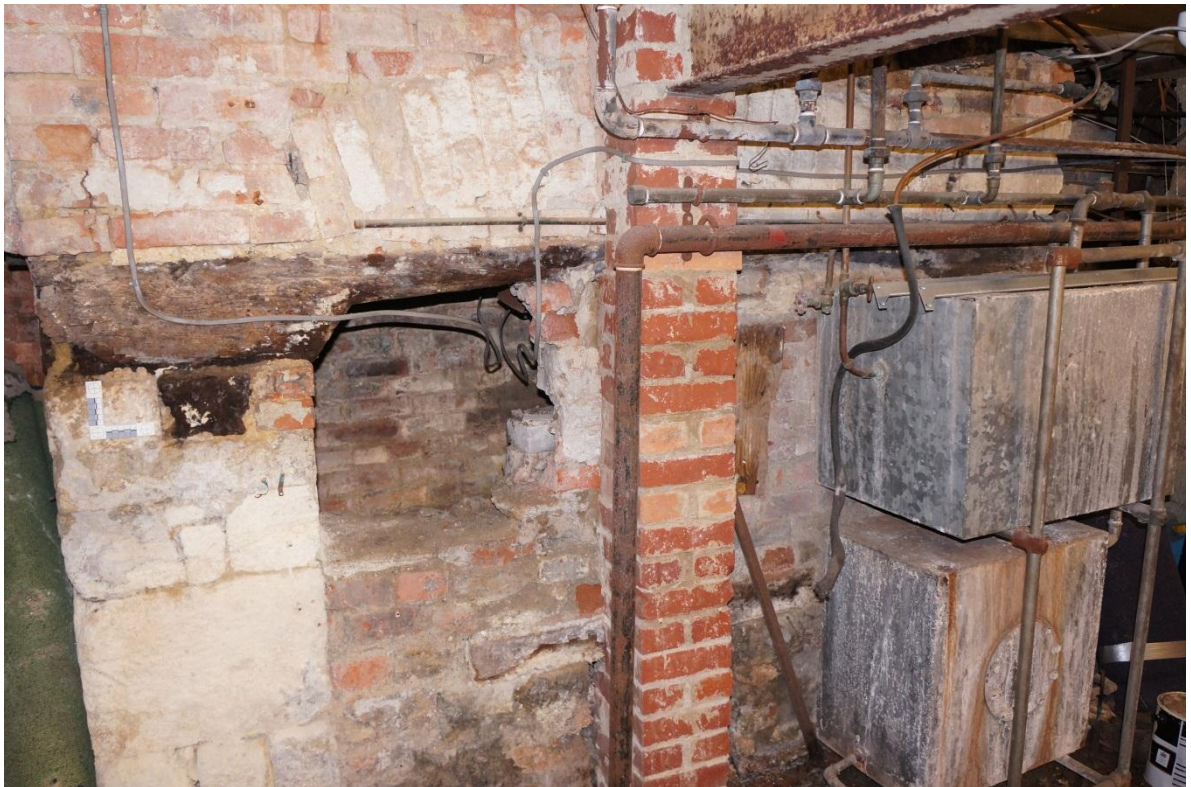
Figure 10 a re-used stone fireplace with an oak mantel in the undercroft of 7 Fore Street, Trowbridge

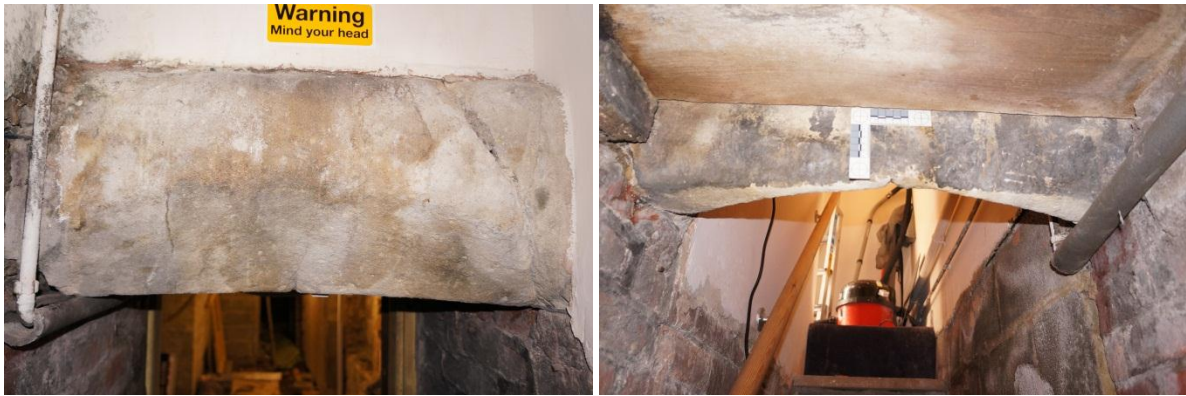
Figure 11 a well-shaped and re-used stone lintel above the entrance to the undercroft of 7 Fore Street, Trowbridge

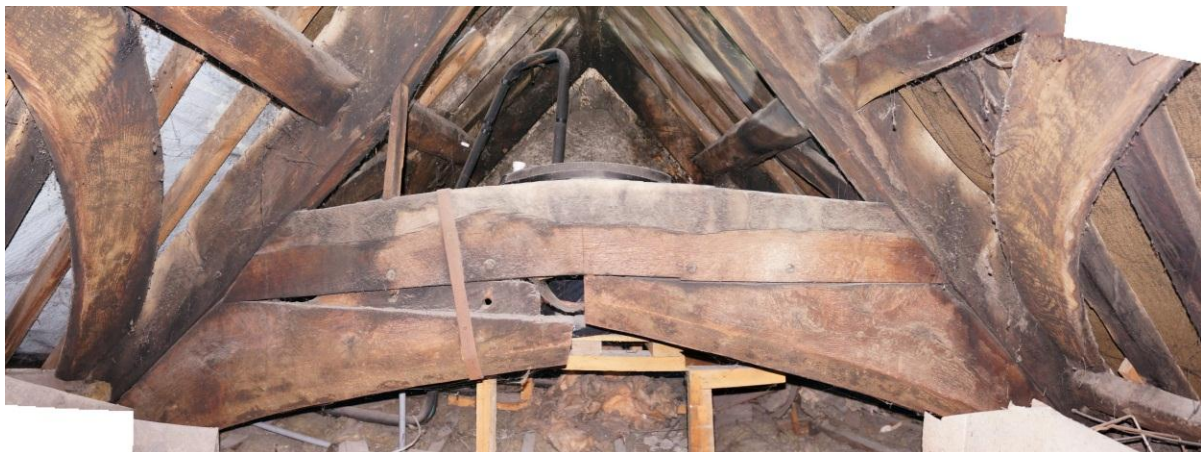
Figure 14 the arch-braced and cranked collar above the once open hall at 9 Church Street

As can be seen above, the collared rafter roof has curved wind braces and inline purlins and is an early example of such, with most instances occurring in the latter half of the 15th century (Haddlesey, 2010). The left hand mortice joint connecting the arched brace to the collar has failed and has been shorn up with a wrought iron cartwheel tyre stave. This type of repair is not common place on failed timber joints until the 16th century at the earliest (Hillman-Crouch, 1999, 44). Therefore, it can be implied that the original open hall structure was intact until at least the 16th century, a time when many open halls were converted into closed hall houses with a floor above and a brick chimney. A practice that would alter the structural integrity of any converted building. The open hall was a hugely important aspect of late medieval society, forming the central space within a house where

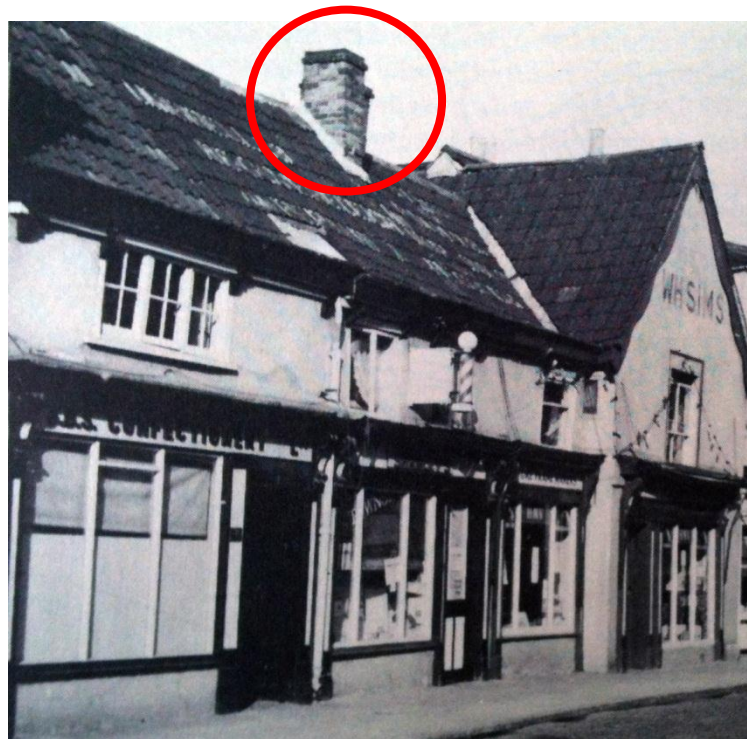
Figure 15 a c.1930s photograph of 9 Church Street with an inserted (and now removed) brick chimney (Rogers, 1984, 24)

The rear wing that runs at right angles to the sweet shop in the left of Figure 15 is also timber-framed, but its raised ridge line and carpentry suggests a later date than the 1439 front wing (Figure

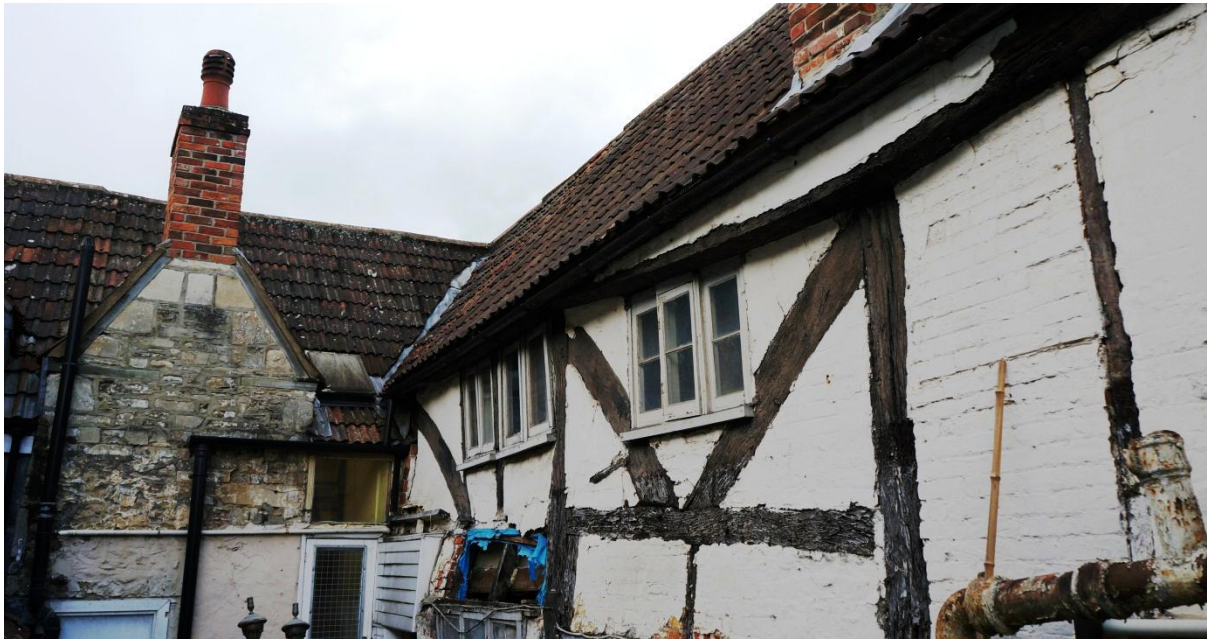
16). Little of the rear wing is visible but I would suggest a date towards the end of the 15th or early 16th century based on style. The rear of the jettied wing was also extended sometime later; however, it is not possible to date this extension.

Figure 16 the rear of 9 Church Street showing a chimney on the rear wall of the hall and the later added wing on the right of the picture

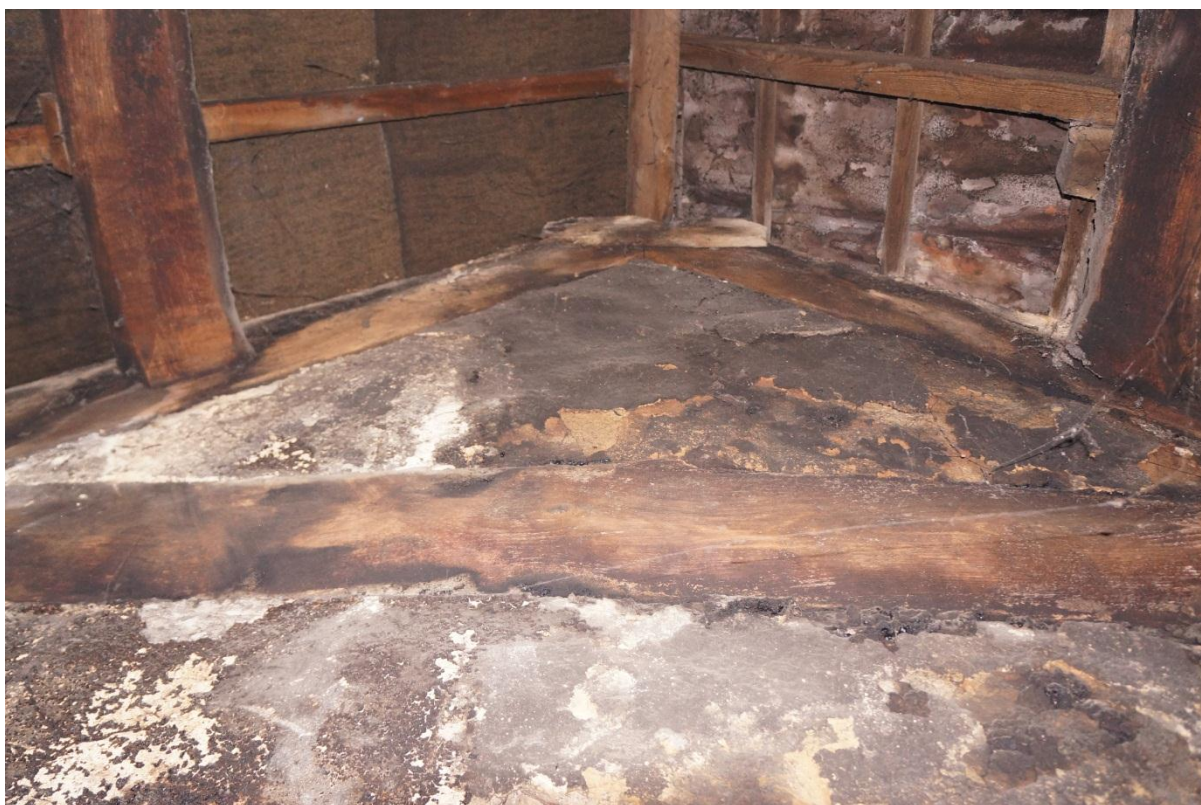
During the survey soot and fatty crystalline deposits were recorded above the area of the proposed open hall (Figure 17). Finding soot in the roof of a suspected hall house is generally a sure sign that originally the house had an open hall prior to the start of the 16th century. However, it is not an indicator as to the exact location of the open fire because smoke dissipates freely, whereas, the heavier fatty deposits tend to rise straight up giving a much better estimate as to the location of the original hearth (Crook, 2006). The crystalline deposits are an outcome of cooking meat on the open hearth and are a result of fat rising with the smoke and depositing on the roof structure. The greatest concentration of which, occurred on the left hand side of the hall as you look at it from the street. This would indicate the hearth was also on this side of the hall and, therefore, suggests the high end –i.e. the side the homeowner sat - was also to the left of the hall. This too is a sure indicator that the parlour and solar were on the left of the hall and the service end towards the far right of the hall.

Figure 17 Evidence of heavy sooting and fatty crystalline deposits within the roof space above the hall of 9 Church Street

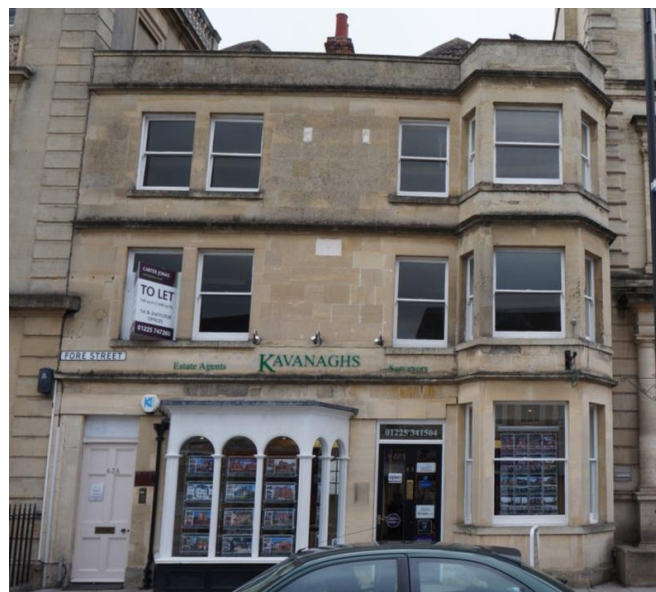
appearances. One of these buildings is no 63 Fore street a medieval building with a 1789 front” (*ibid.*). As Rogers suggests, the front of the building has been stone clad during the Georgian period in the local sandstone (Figure 18 and Figure 19).

Figure 18 the front of 63 Fore Street showing the 1789 stone cladding

Figure 19 the 1789 stone clad front of 63 Fore Street, Trowbridge. This Georgian facade masks the original timber-framed structure and uses a raised parapet to obscure the two roof gables

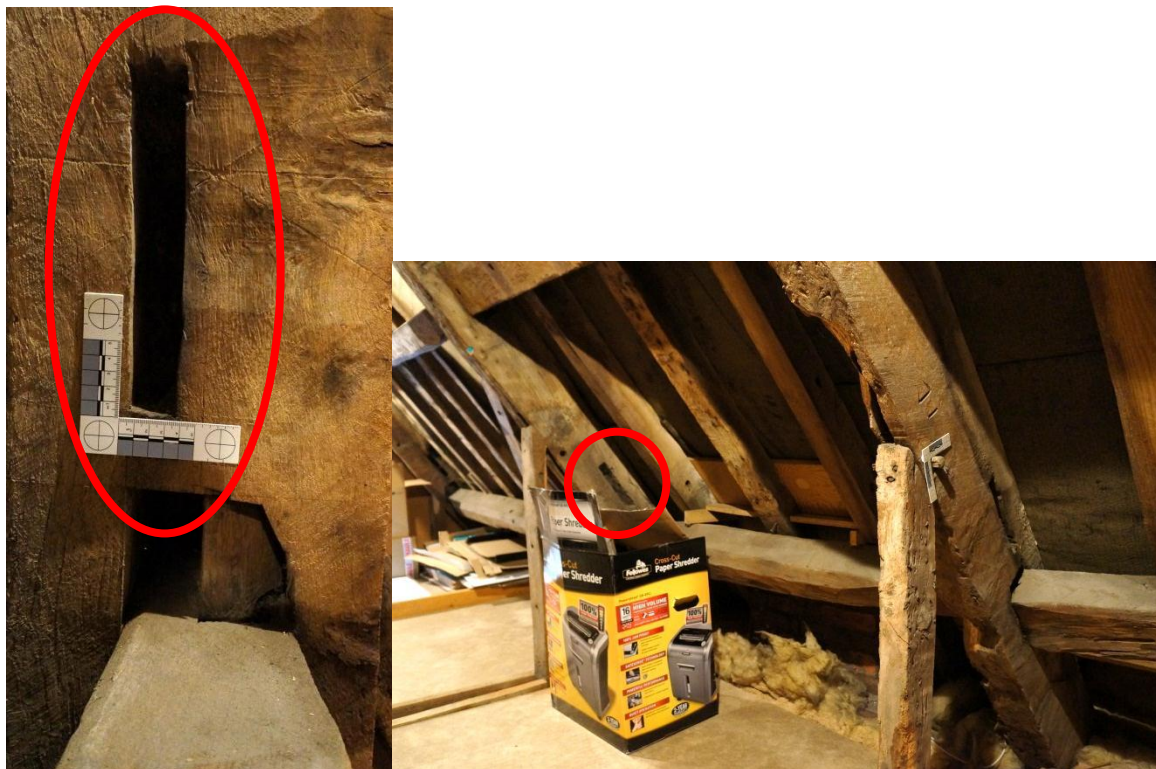
The medieval timber frame which survives in the rear of the building, and its roof, has recently been dendrochronologically dated by Dr Andy Moir to probable date for construction of 1513 (Moir, 2013a). This building has been much altered by the Georgians and its original floor plan is not obvious to the casual observer. However, during recent investigations by Moir (*opp cit.*) and the author; the building has slowly released some of its secrets regarding its original layout. One of the most perplexing was the re-used timbers in the roof structure above the main body of the shop. The tree rings are consistent with those of the rear range and therefore, probably also date to 1513 (*ibid.*). I believe the timbers in the two gabled roofs are from the original roofs that would have been much lower –i.e. the same height as the rear range when they were first built. They would have been raised by the Georgians to create a grander frontage and typical Georgian Town House design (Breckon, et al., 2001, 33) with a raised parapet obscuring the two roof gables (Figure 19). Often too, the pitch of the roof was lowered to transform an attic space into a usable room (Smith and Yates, 1992, 562) as appears to be the case here (Figure 21). One of the main indicators the roof has re-used timbers are the empty mortise joints and crudely cut replacement mortise's below them to house the purlins. I would suggest the mortises that now house the purlins are a later addition because they have been cut into seasoned oak rather than “green” oak as the ones above would have been and highlighted in the images below.

Figure 20 re-used roof timbers above 63 Fore Street with empty mortises highlighted

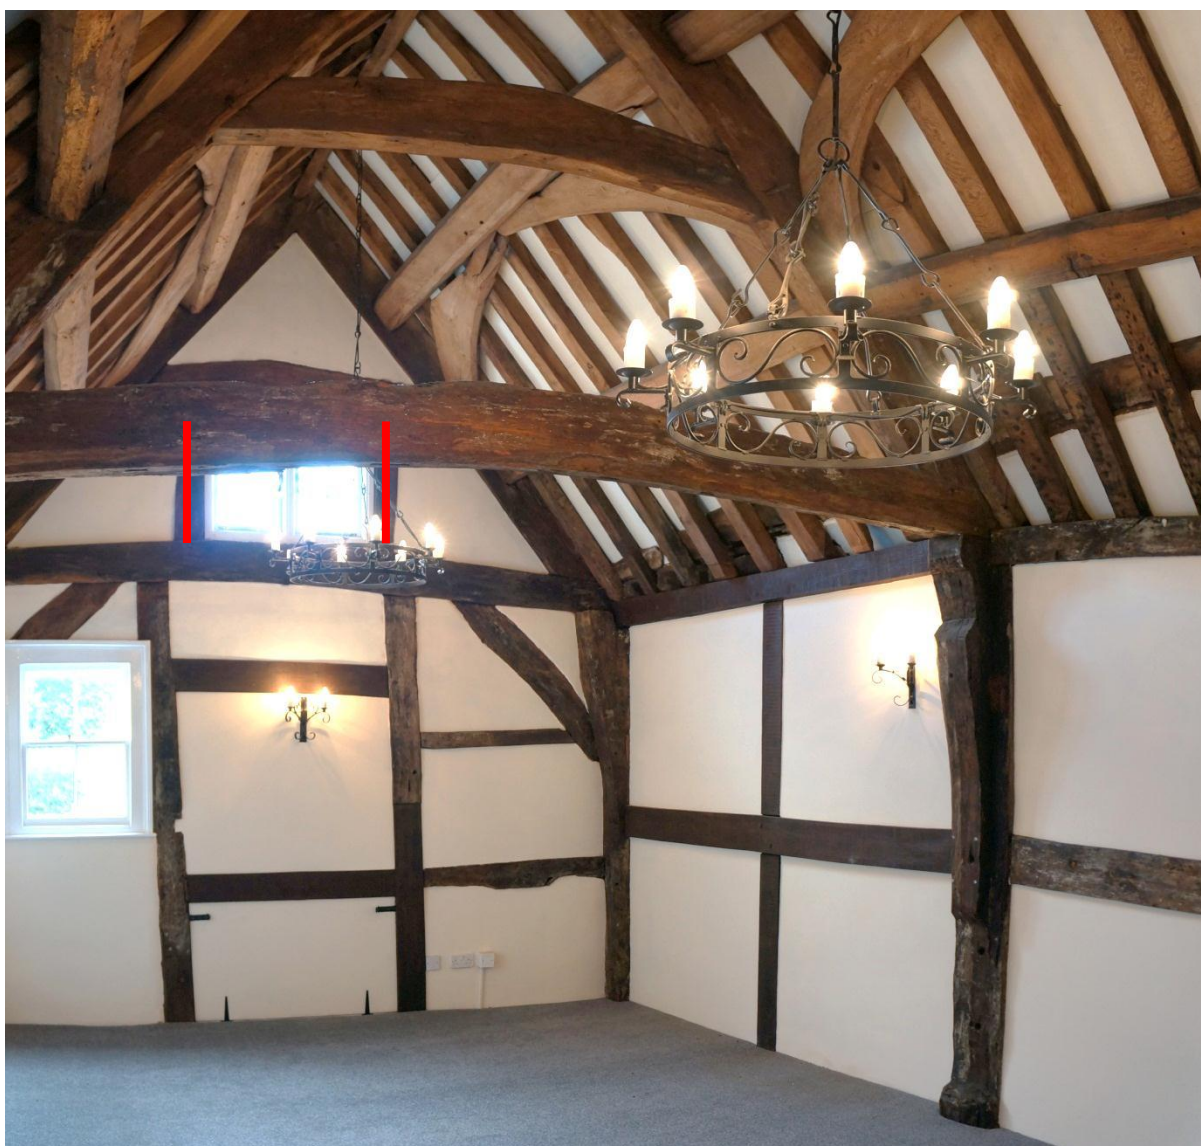
Figure 22 the rear 2 bay range of 63 Fore Street with its exposed timber frame with queen struts (in red) at the rear of the room and a central tie beam supported by gun-stock jowls

The room pictured above consists of two bays; unusually the rear bay (Figure 22) has queen posts between the tie and collar, whereas the front bay has a king post between tie and collar (Figure 24). The central tie beam is slightly cranked, as is the collar above it. The jowl in central post shown in Figure 22 has been modified, but it is unclear why. However, the central tie beam did show evidence of empty mortises which would imply the two bays were divided into two separate bays sometime after construction (Figure 23). The reason why I suggest later, rather than at the time of construction, is because the mortises are very shallow and look to have been cut into seasoned wood rather than green wood which would have been softer and easier to cut.

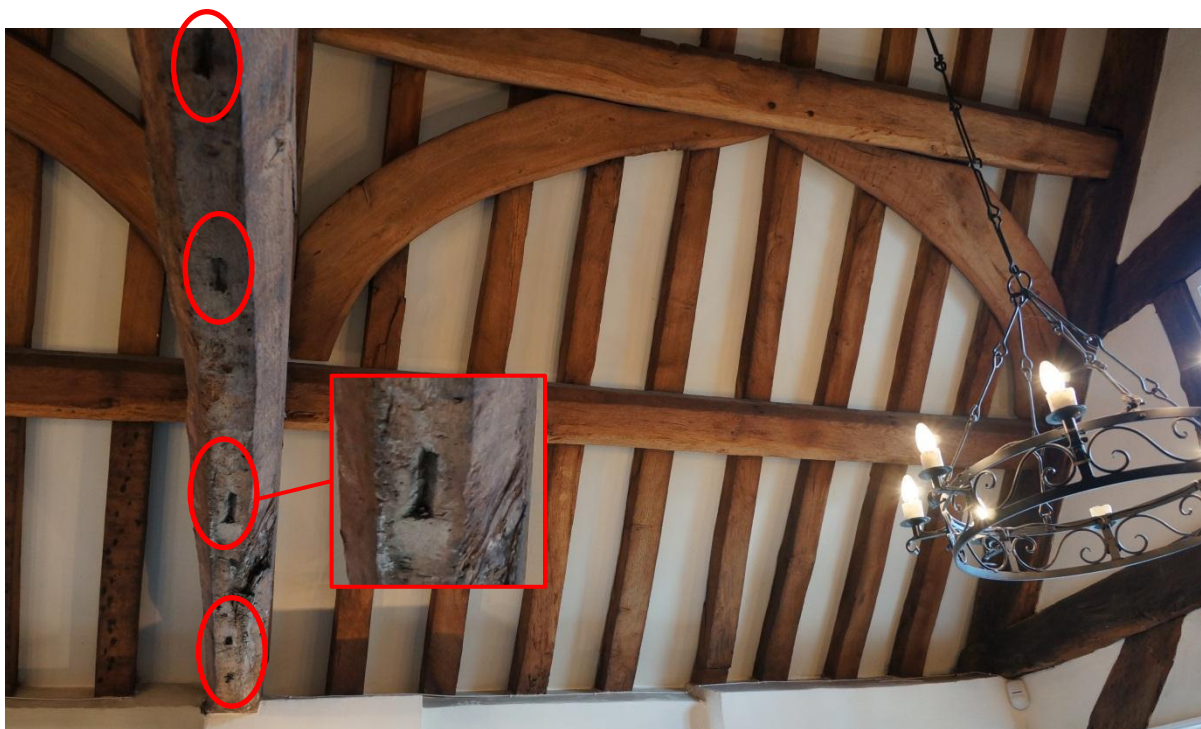
Figure 23 evidence of shallow mortises cut sometime after the initial construction to house a partition to separate the open two bays into two rooms

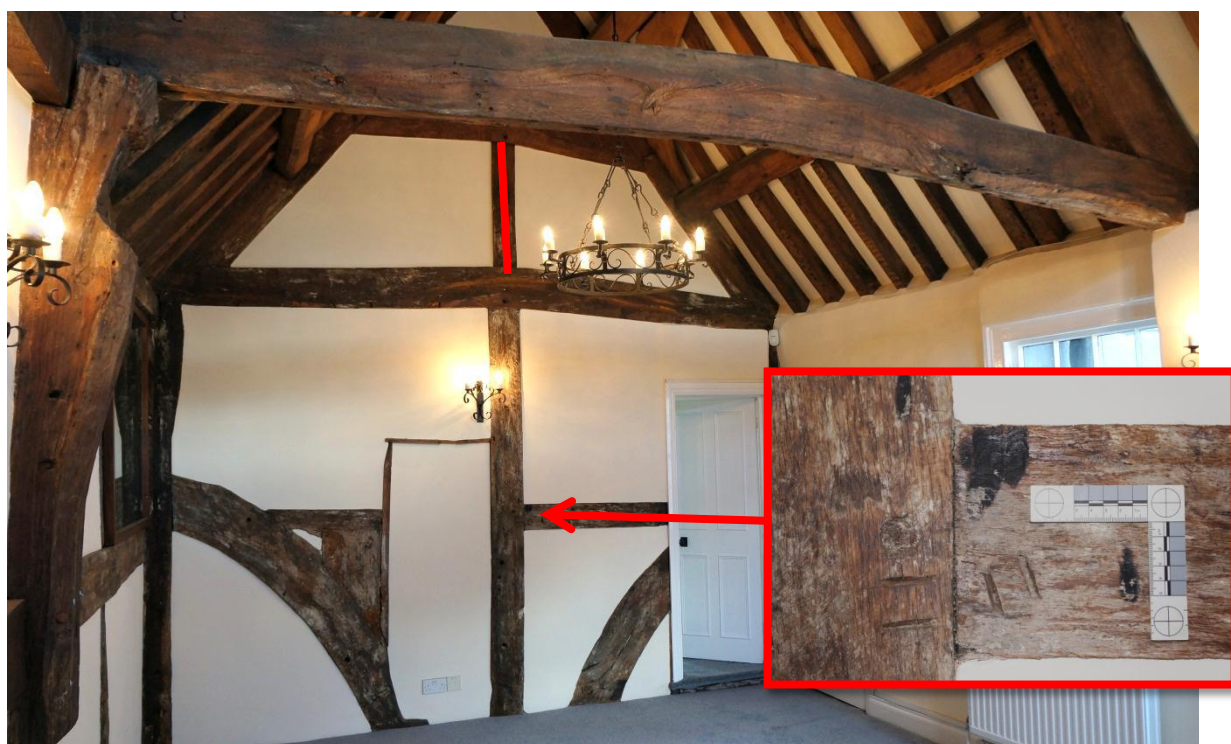
Figure 24 the front side of the rear range with its king post highlighted in red in the upper part of the image with evidence of the use of rush lights or "dip lights" to illuminate the room at mid rail height

There was no conclusive proof of any sooting, however, burning was evident as a result of rush lights (or “tallow dips”) being used at mid-rail level around the room (Figure 24). The use of such lights often leaves a distinctive “tear drop” burn pattern in the wood. It is made by impregnating a rush with tallow to make a candle. The tallow was derived from fully melting sheep and cow fat and then skimming off the top crust and sieving out any impurities before dipping in the rush wick. This type of candle was known as a “tallow dip” (Phillips, 1999, 72). A rush light is fairly simple to make and a common sight in late medieval solar’s. I would therefore conclude that this two bay room was constructed as a solar, lighted by rush lights, and later divided into two separate living areas. What is unclear however is whether this part of 63 Fore Street was built at the same time as the rest of the building? If we go by the tree-ring dates we can see the timbers from the front and rear are consistent and both date to around 1513 (Moir, 2013b). Not only that; all the walls are single thickness suggesting one structure. What makes me question this, is the fact that there appears to be an *in situ* wall post in the room in front of the solar described above (Figure 25).

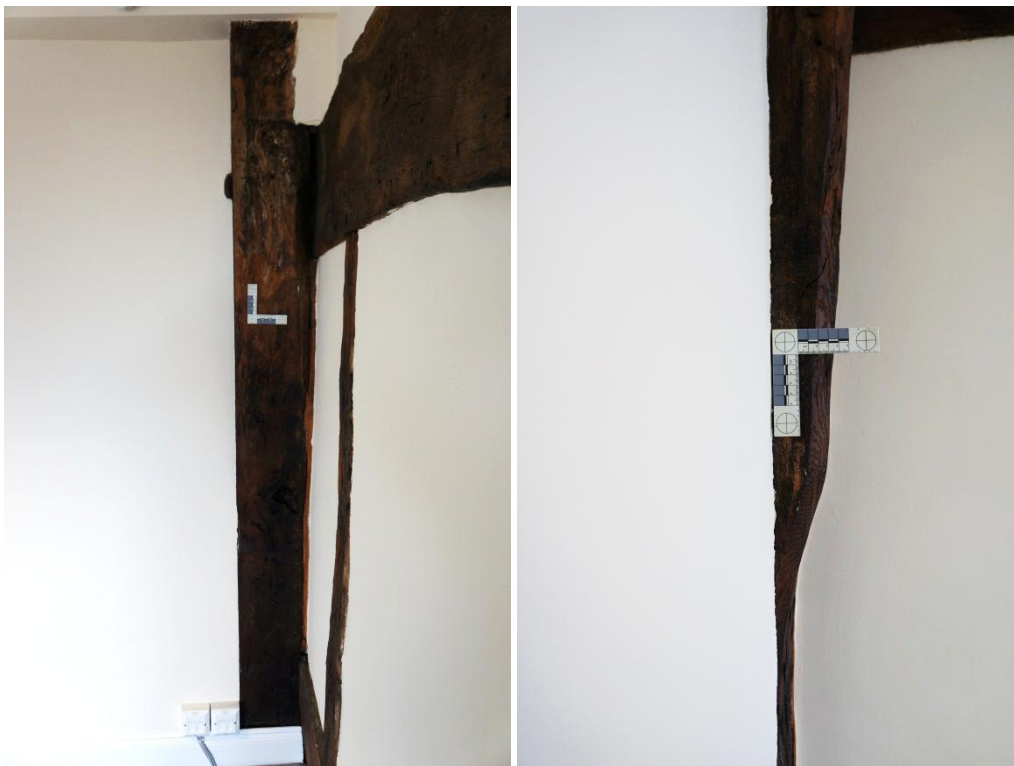
Figure 25 a corner wall post above the main body of 3 Fore Street suggesting a separate timber frame from that of the coeval solar behind it

This wall post could easily be overlooked as just an anomaly if it were in isolation, but, the existence of another roof construction running at right angles to it (Figure 26) together with remains of a

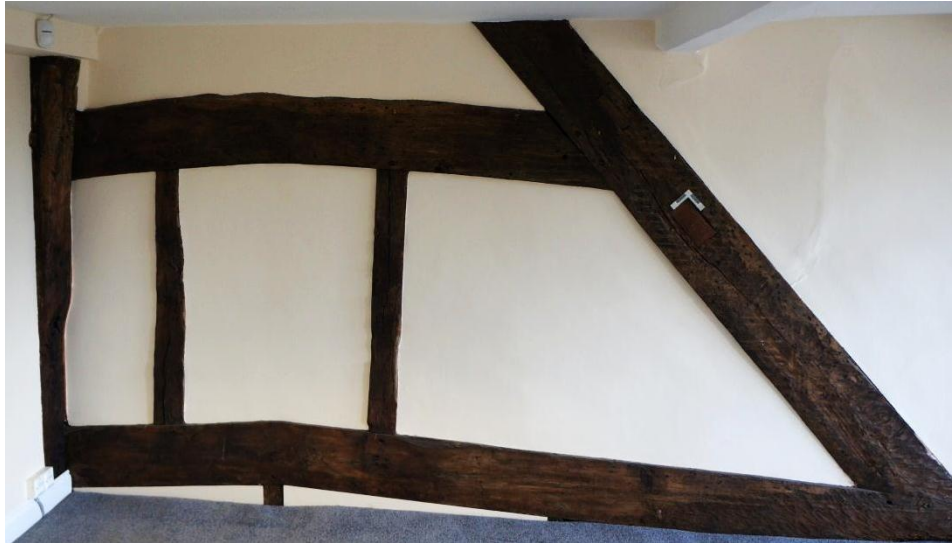
Figure 26 a queen post roof with cranked tie-beam belonging to 62 Fore Street exists at right angles (and therefore parallel to Fore Street) to a wall post of 63 Fore Street

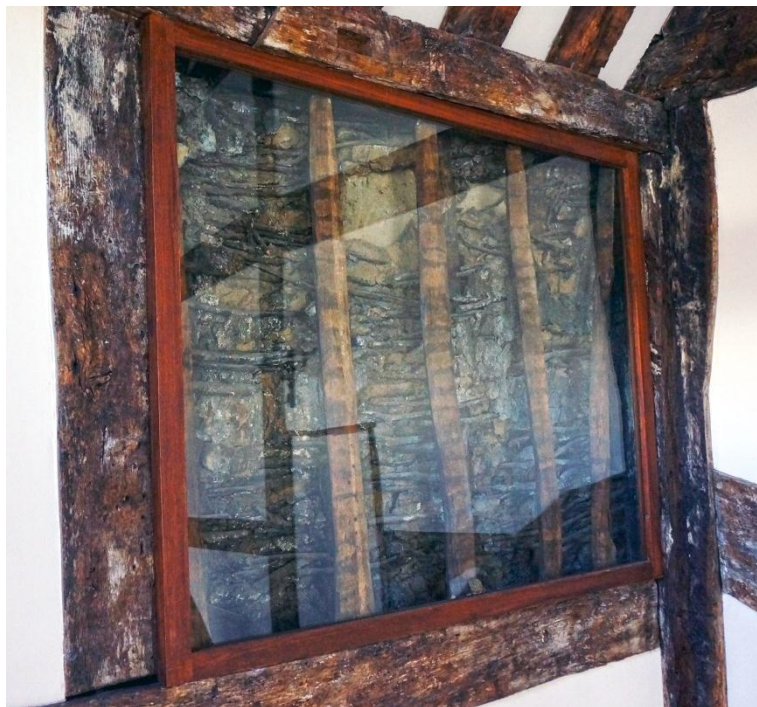
second wall visible in the solar (Figure 27); would indicate this room has been widened by removing the inner timber-frame. This, I would suggest, happened during the time of the Georgian remodelling c.1789 (Rogers, 1984).

Figure 27 the wattle and daub from the solar wall has been removed to expose the wattle and daub of 62 Fore Street. The timber staves (uprights) belong to the solar

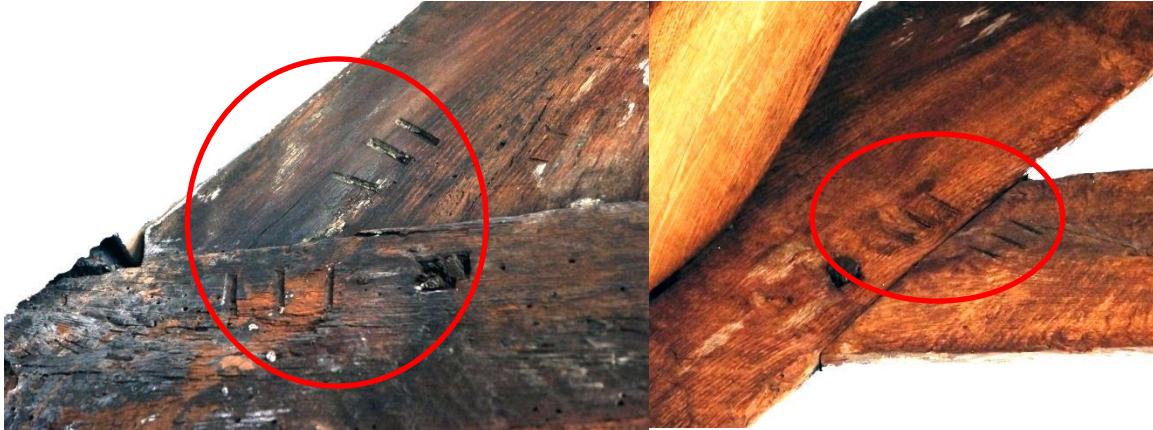
Another item of note is the similarity between the carpenters marks found in the Solar (Figure 24 and Figure 28) and those found in the reused timbers in the roof above the main structure (Figure 29). Note – although the actual marks differ, the tools which made them are the same. These are very different to those found on the remaining roof timbers of the adjacent building of 62 Fore Street (Figure 30).

Figure 28 carpenters marks found in the Solar of 63 Fore Street

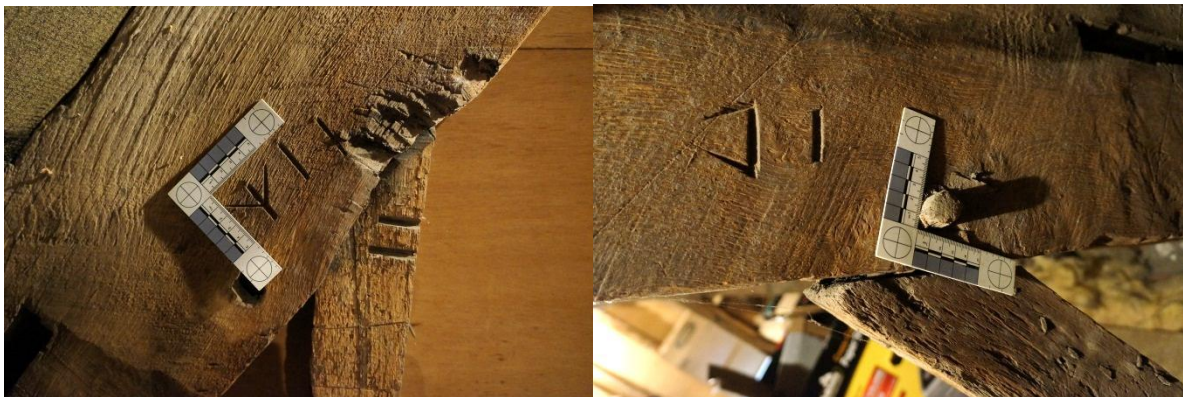
Figure 29 carpenters marks found in the reused timbers of the main roof of 63 Fore Street

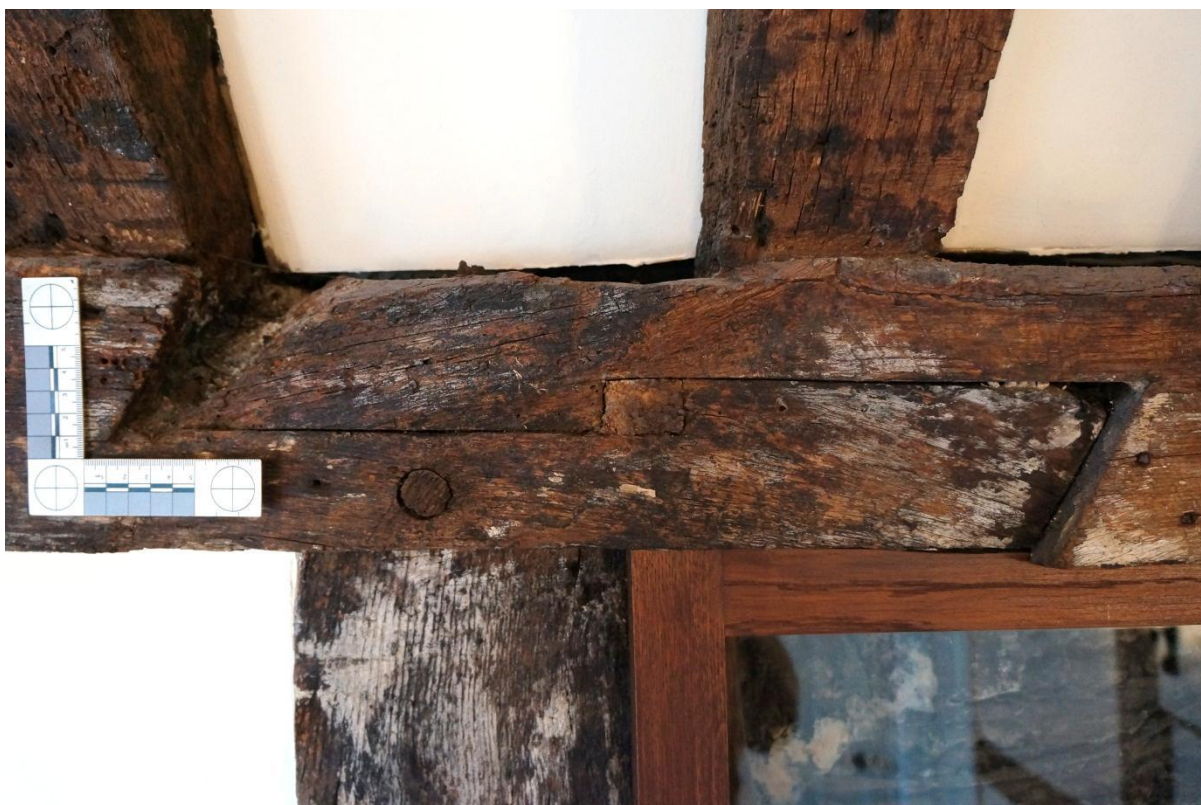
Figure 32 a previously unseen undersquinted butt in a halved and tabled scarf with key in the Solar of 63 Fore Street

What is remarkable in this scarf is the use of the key, which is a wedge driven into the centre of the joint to force it apart. Traditionally these are only found in splayed scarfs (Figure 31) and then, only prior to the mid-14th century (Haddelsey, 2010). So to find a key in a halved scarf in the early 16th century is indeed worthy of note and further inquiry.

Also worthy of note in the solar is the very unusual scarf joint. I have never come across this joint before and it also seems absent from the reference books. It is similar in essence to a stop-splayed and tabled scarf with key (Figure 31), but in this instance – the scarf joint is face halved rather than splayed (Figure 32).
